NATIONAL ADVISORY COMMITTEE FOR AERONAUTICS

TECHNICAL NOTE 3269

ADDITIONAL STATIC AND FATIGUE TESTS OF HIGH-STRENGTH
ALUMINUM-ALLOY BOLTED JOINTS

By E. C. Hartmann, Marshall Holt, and I. D. Eaton

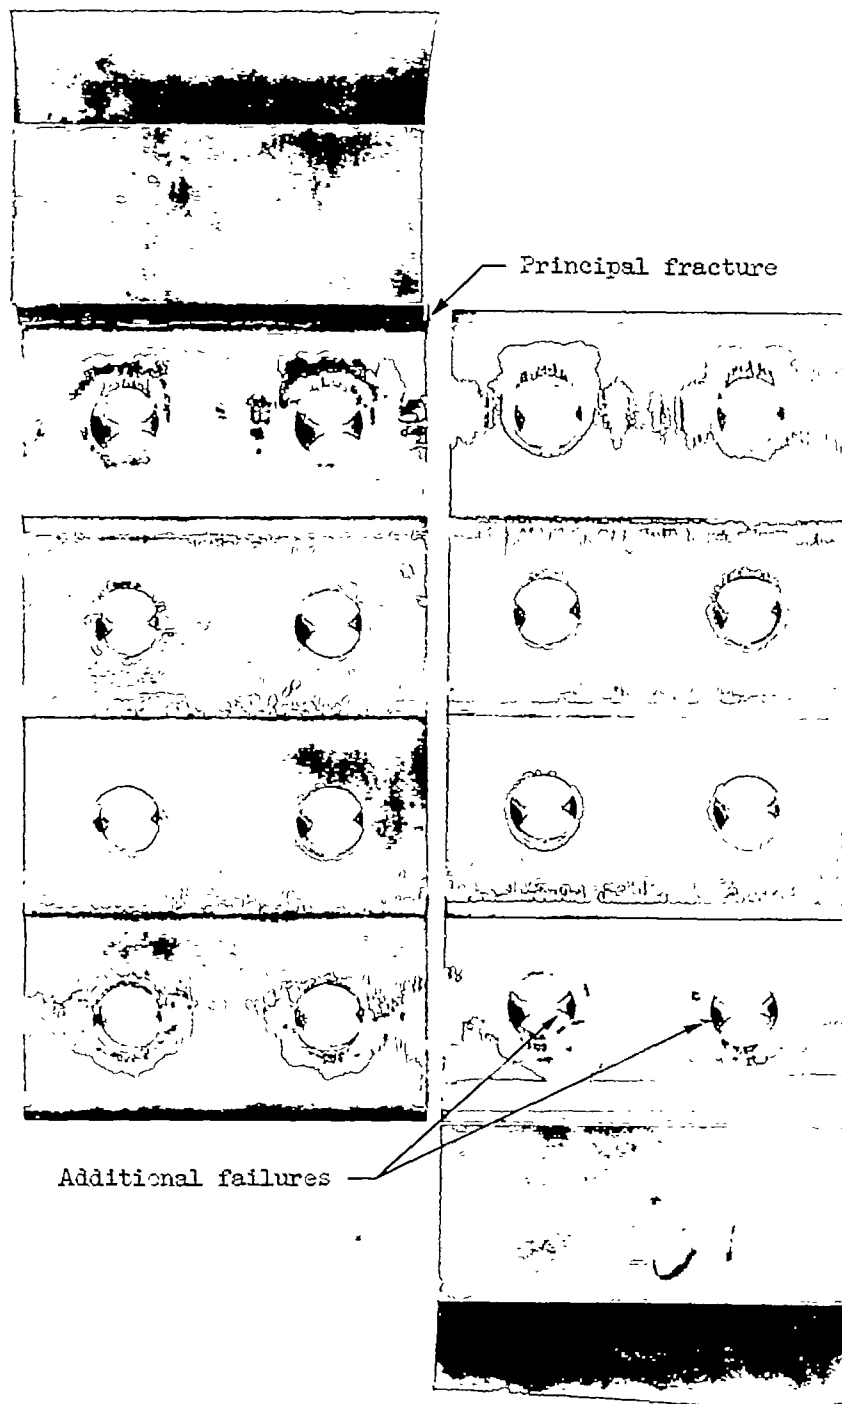
Figure 17.- Failures in 24S-T4 nonuniform-step joint. L-83697

When the bolts were removed individually from the reassembled joints, it was found exceedingly difficult to obtain evidence of the existence of some of the cracks by means of the penetrant inspection methods used. In the case of the smallest crack no evidence of its existence was found. Further, no indication was obtained of the existence of the crack, about 0.009 inch long, shown in figures 17 and 18 when the methods were used with this joint in the disassembled condition.

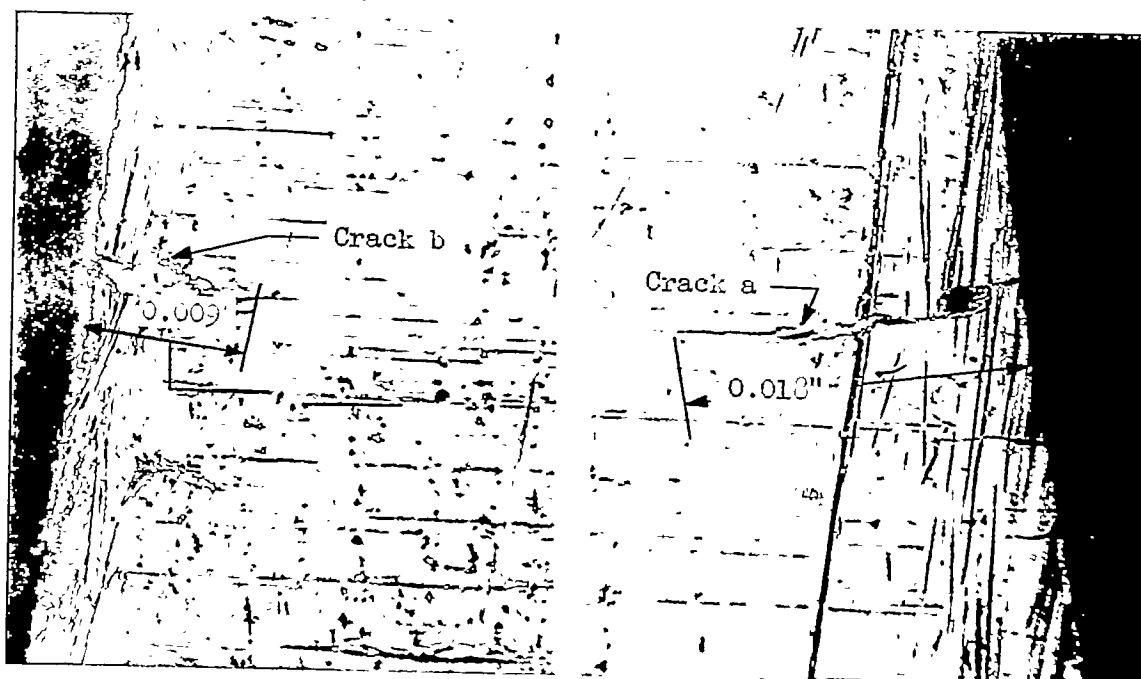
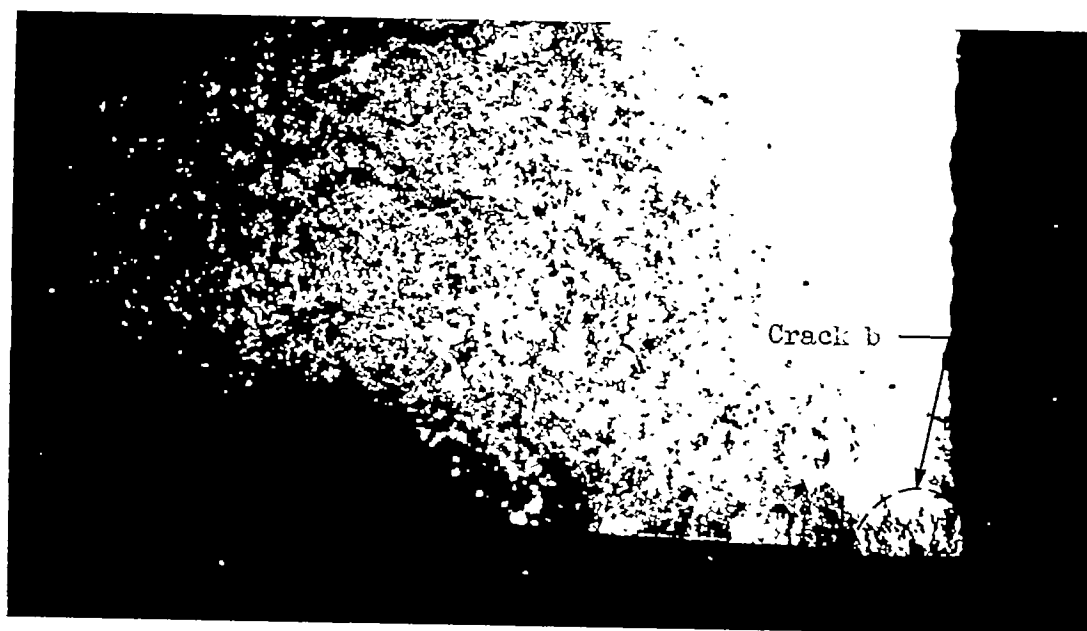
Figure 18.- Enlargements of additional failures in 24S-T4 nonuniform-step joint. (For locations, see fig. 17.) Two photographs at top are of Faxfilm replicas.

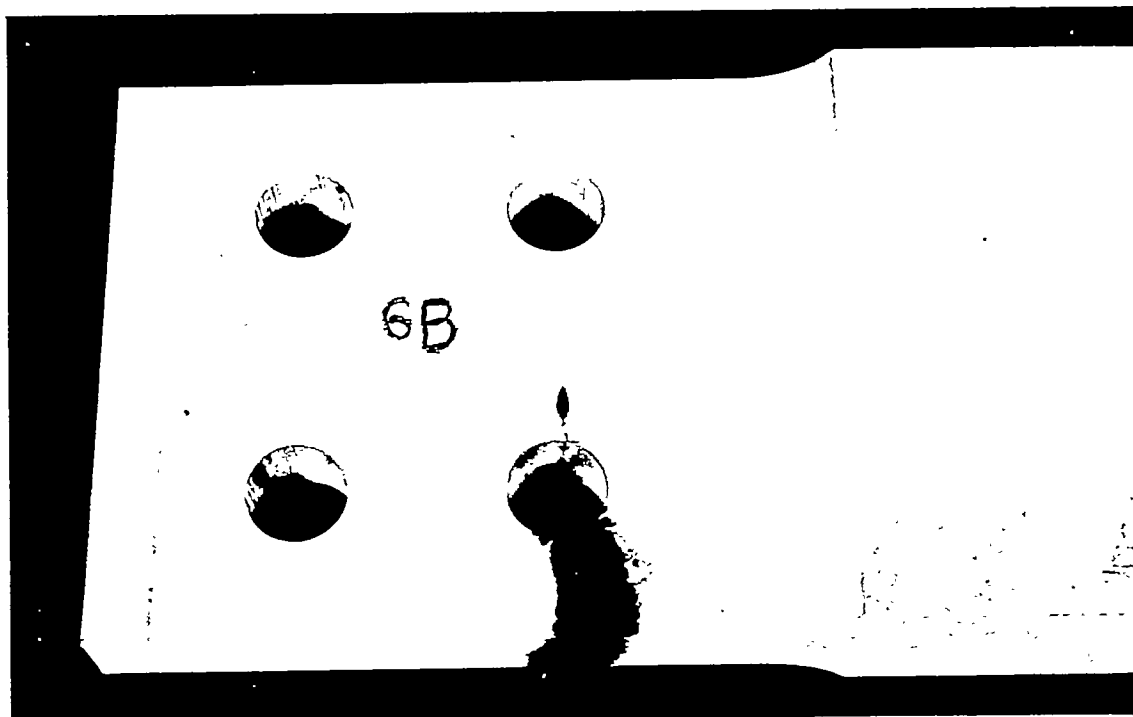
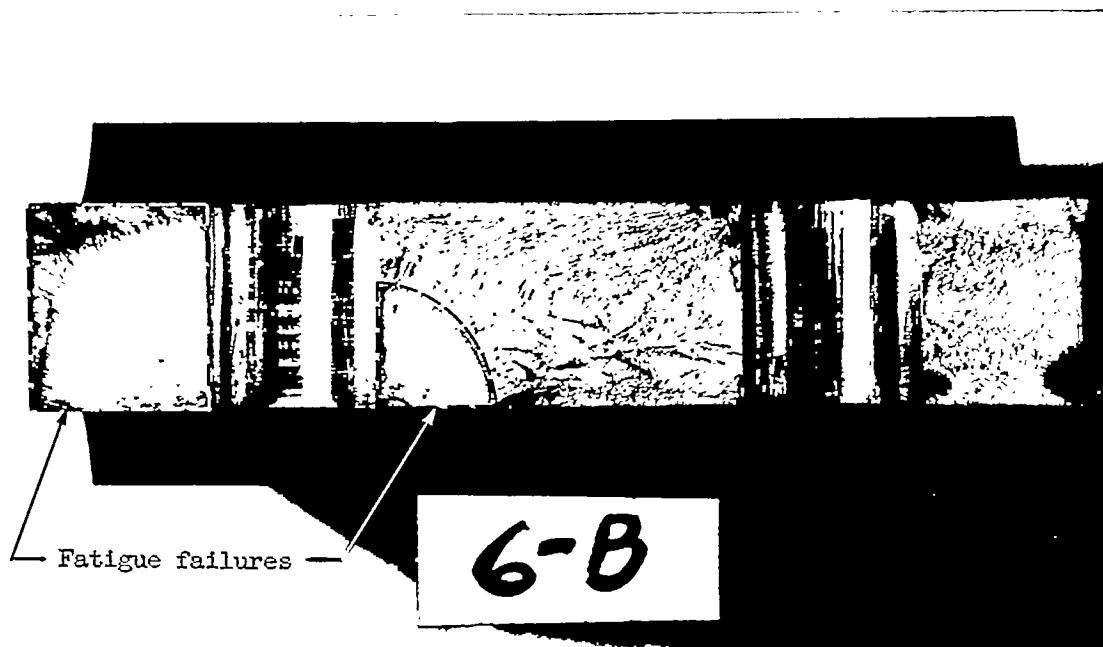
Figure 19.- Failures in 75S-T6 double-shear joint.

The static loads required to fail the 75S-T6 and 24S-T4 double-shear joints after the fatigue cracks shown in figures 19 and 20 had been developed are given in table VII. Included in the table are comparisons with the expected load based on the net area obtained by correcting for the cracks and the load-carrying capacity of a similar joint not having previous cyclic-stress history. Outlined on the fractured surfaces in figures 19 and 20 are the areas involved in reducing the net area for estimating the effective load-carrying section of the specimens. It can be seen that one section of the 75S-T6 joint between the bolt hole and the outside edge was completely fractured by the fatigue loading whereas the 24S-T4 joint did not completely fracture in this area. Before subjecting the 24S-T4 joint to the static loading, however, a saw cut was made into the bolt hole from the outside edge in order to produce more nearly identical conditions in the two specimens. The location of the cut is shown in figure 20. Thus for purposes of the comparison this section of the joint has been considered as though it had been completely fractured in fatigue. Further, the additional failure in the centrally located portion of the joint adjacent to the bolt hole in the 75S-T6 joint caused a substantially larger reduction in the section than was the case in the 24S-T4 joint. Thus the cracked 75S-T6 joint would be expected to be subjected to a larger eccentricity of loading than the cracked 24S-T4 joint.

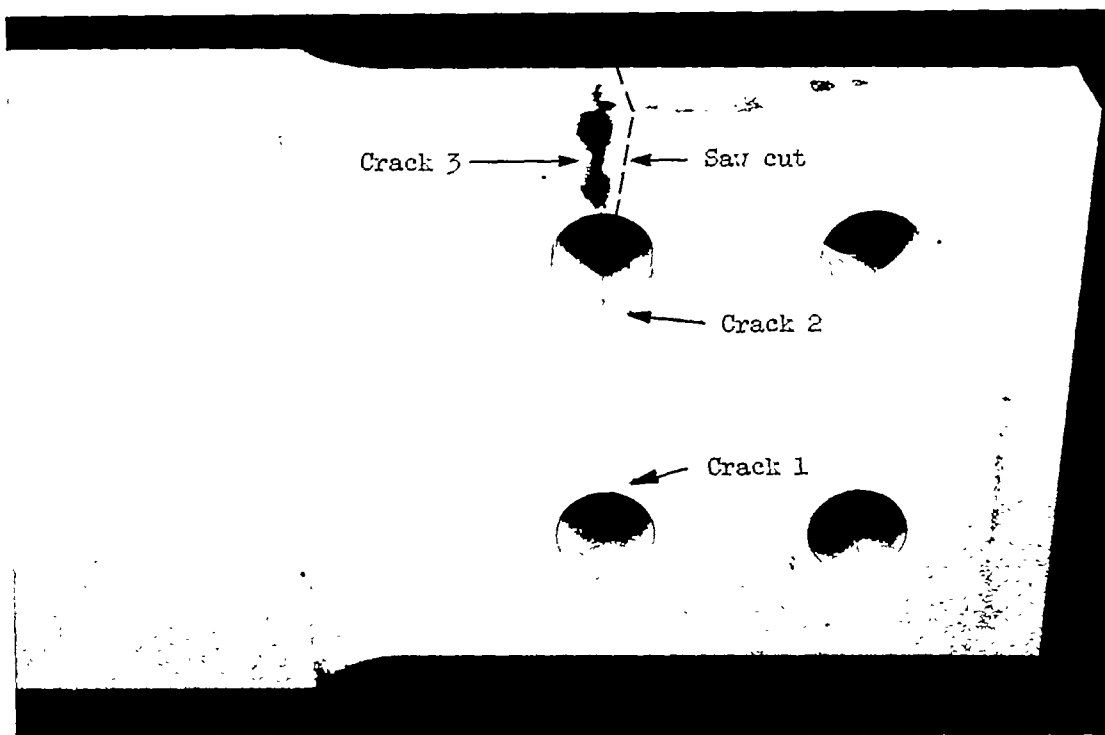
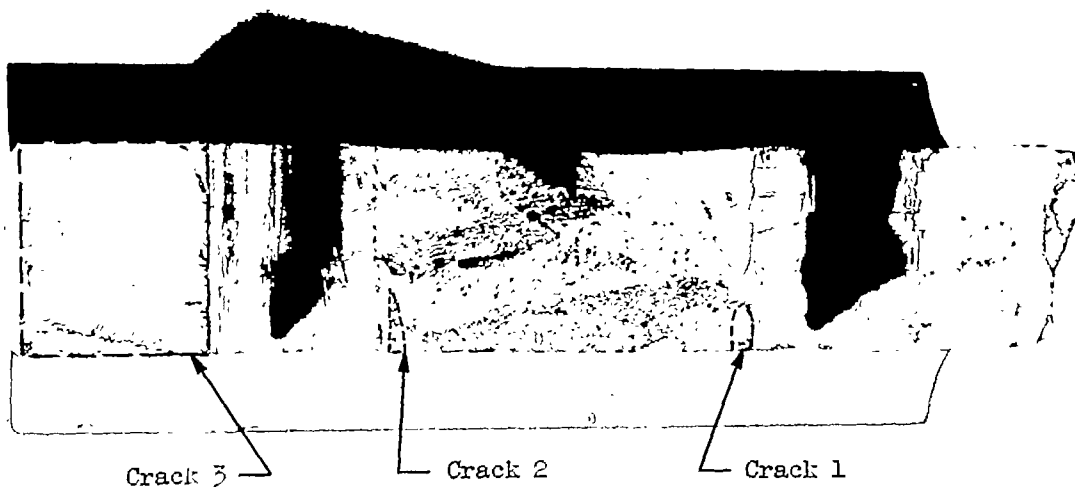
Figure 20.- Failures in 24S-T₄ double-shear joint. Specimen 6D. (For enlargement of small cracks see fig. 21.)
